METALS HANDBOOK

VOL. 9
FRACTOGRAPHY AND ATLAS OF FRACTOGRAPHY

8th EDITION

Fractography and Atlas of Fractographs

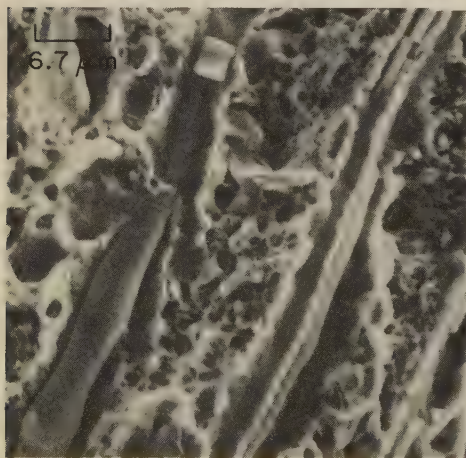
SEM fractograph 1500×
Stringers are visible as parallel features inclined about 30° to right of vertical. They were not identified as to composition, but may be accidentally entrapped slag that was elongated in the major direction of flow during forging.

Fig. 16. Stringers on the surface of a fracture that occurred during straightening of a 4340 steel forging that had been heat treated to a tensile strength of 1380 to 1520 MPa (200 to 220 ksi)

working. Nonmetallic stringers usually form from deoxidation products or slag, but may also result from the intentional addition of elements such as sulfur to enhance machinability. Figure 16 shows unidentified stringers on the fracture surface of a 4340 steel forging. Overload cracking occurred during straightening after the forging had been heat treated to a tensile strength of 1380 to 1520 MPa (200 to 220 ksi).

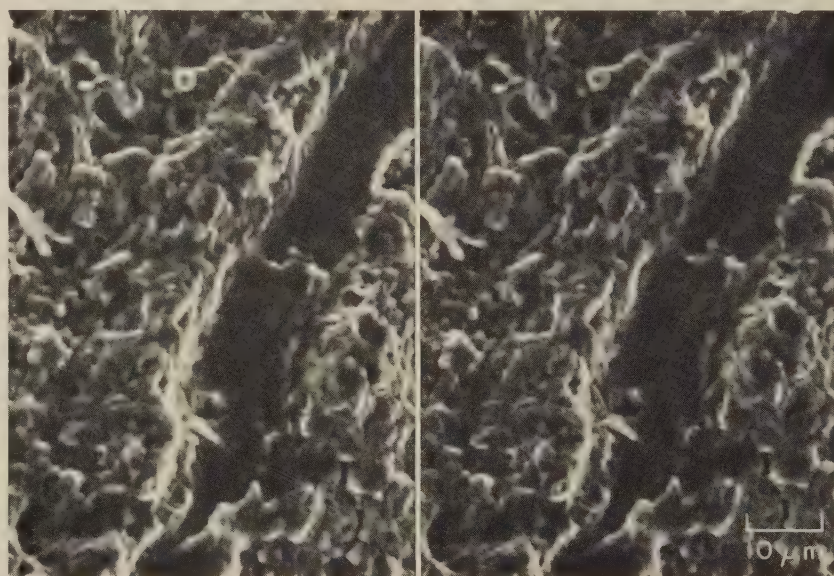
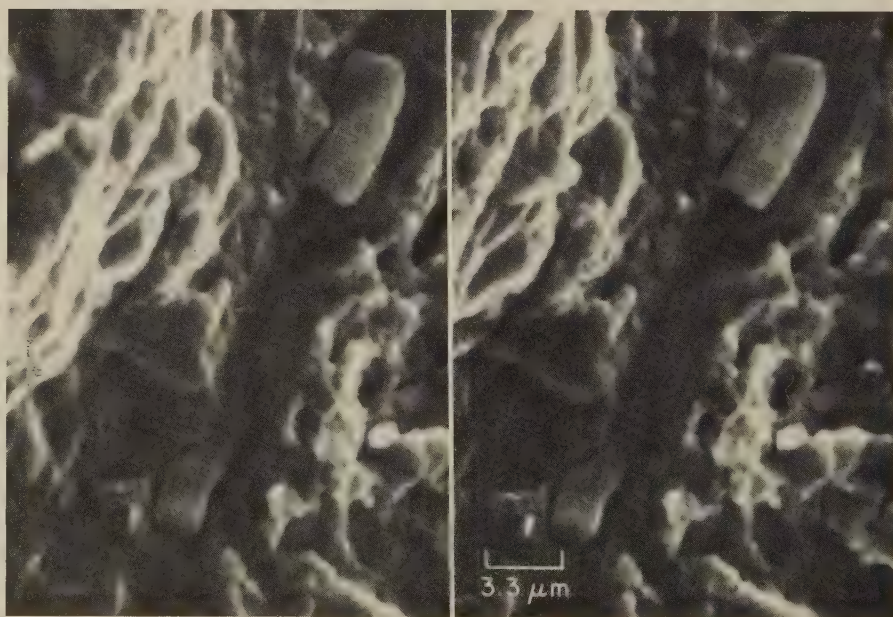
Fig. 17. Stringer and two stringer troughs on the fracture surface of 4340 steel heat treated to a tensile strength of 1310 to 1450 MPa (190 to 210 ksi). Stereofractograph at top shows a trough that earlier contained a stringer. Stereofractograph at bottom shows a trough that still contains two portions of a stringer.

The stereo pairs of SEM fractographs in Fig. 17 show a stringer similar to those in Fig. 16, and two stringer troughs, in a fracture in 4340 steel heat treated to a tensile strength of 1310 to 1450 MPa (190 to 210 ksi).

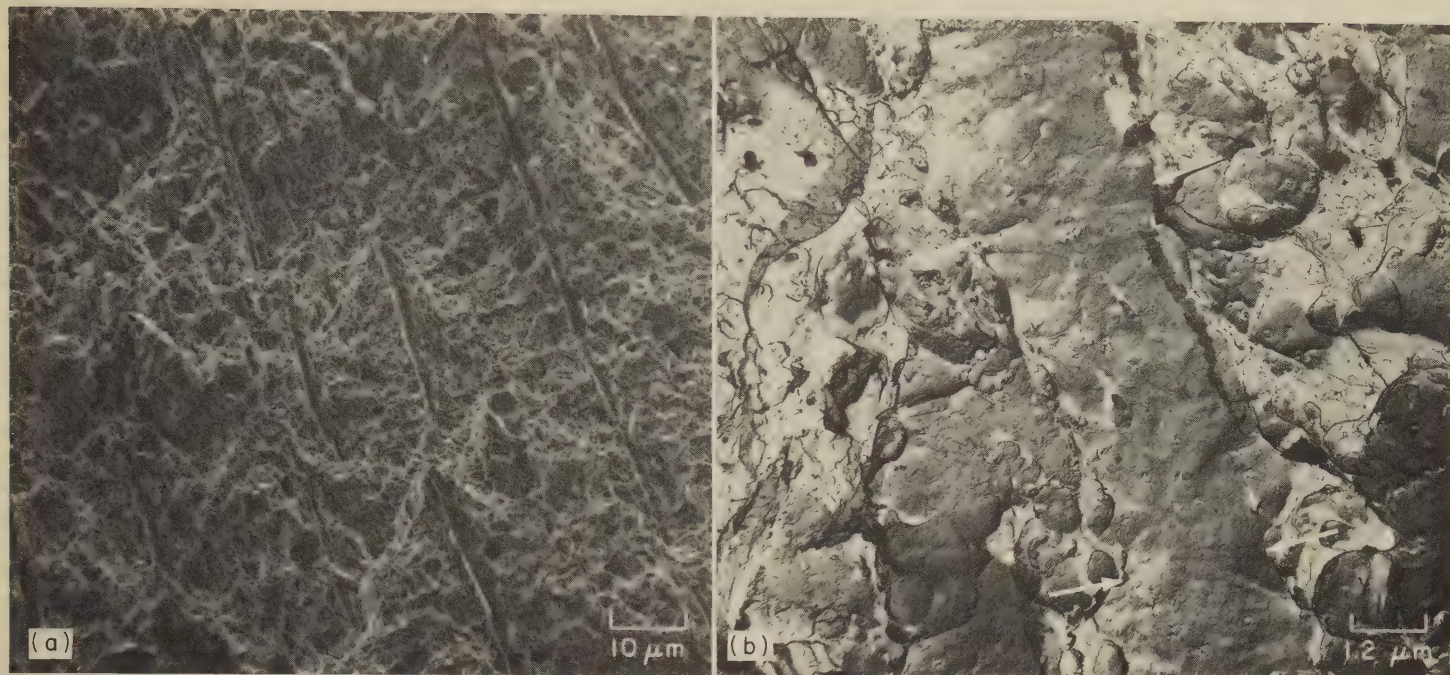
Fig. 18. Stringer troughs in the surface of an overload fracture in 4340 steel heat treated to a tensile strength of 1790 to 1930 MPa (260 to 280 ksi). (a) SEM fractograph showing several troughs. (b) TEM fractograph showing dimples of various sizes on either side of a trough (between pairs of arrows). (J. Kilpatrick, Delta Air Lines)

Figure 18 presents a comparison of the appearance of stringers and troughs when examined with a scanning electron microscope and with a transmission electron

microscope. The fractographs show an overload-fracture surface of 4340 steel heat treated to a tensile strength of 1790 to 1930 MPa (260 to 280 ksi).

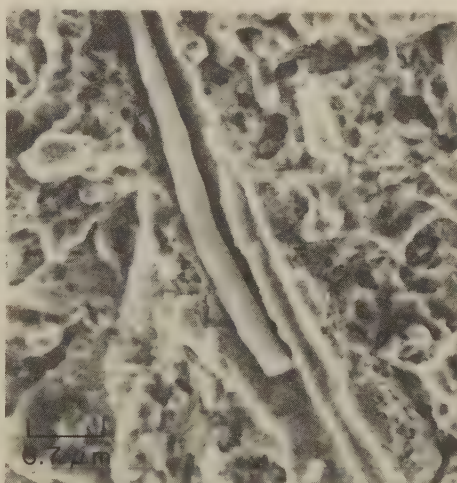
Fig. 19. Sulfide stringer in trough on fracture surface of 6150 steel heat treated to a tensile strength of 1240 to 1380 MPa (180 to 200 ksi)

Figure 19 shows a sulfide stringer in a trough on a fracture surface of 6150 steel heat treated to a tensile strength of 1240 to 1380 MPa (180 to 200 ksi).

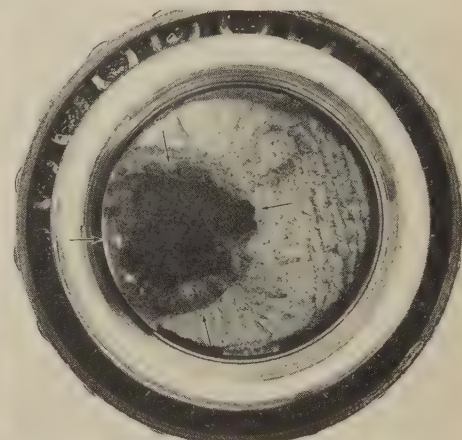
Fig. 20. Fracture through a large shrinkage cavity (arrows) in a spindle shaft made of cast 0.20% C steel. A dendritic structure is present on the surface of the cavity (this is shown more clearly in fractographs 4809 and 4810 on page 382).

Porosity is the name applied to a condition of fine holes or pores in a metal. It is most common in castings and welds, but residual porosity from the cast ingot sometimes still persists in forgings. In fractures that occur through regions of excessive porosity, numerous small depressions or voids (sometimes appearing as round-bottom pits) or areas with a dendritic appearance can be observed. At low magnification, fractures through regions of excessive porosity may appear "dirty" or "sooty" because of the large number of small voids, which look like black spots. A large shrinkage cavity in a fracture through a cast 0.20% C steel spindle shaft is shown in Fig. 20. A dendritic structure is visible in a portion of the cavity.

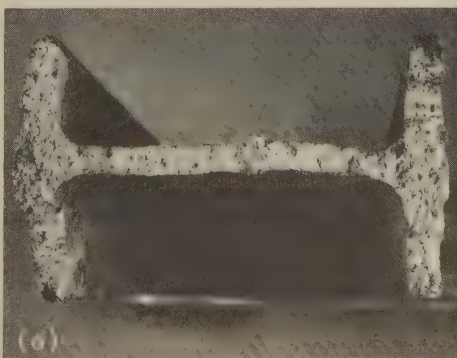
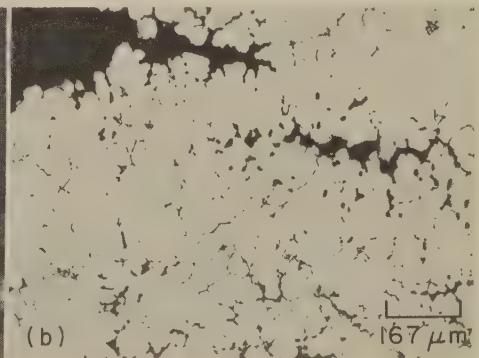
Fig. 21. (a) Fracture through excessive porosity in an aluminum alloy 220-T6 casting. Large voids appear as black spots. (b) Appearance of microporosity in a metallographic section adjacent to the fracture.

Molten aluminum alloys are likely to absorb hydrogen from moisture in the atmosphere or in products of combustion. Liberation of the hydrogen during solidification of the metal can cause gas porosity. A fracture in an aluminum alloy 220-T6 casting is shown in Fig. 21(a). A metallographic section cut from an area adjacent to the fracture is shown in Fig. 21(b). Figure 22 shows random porosity (with pores surrounded by dimples) in a fracture of a cast aluminum alloy A357 air-turbine blade. Fracture was caused by overload from an impact.

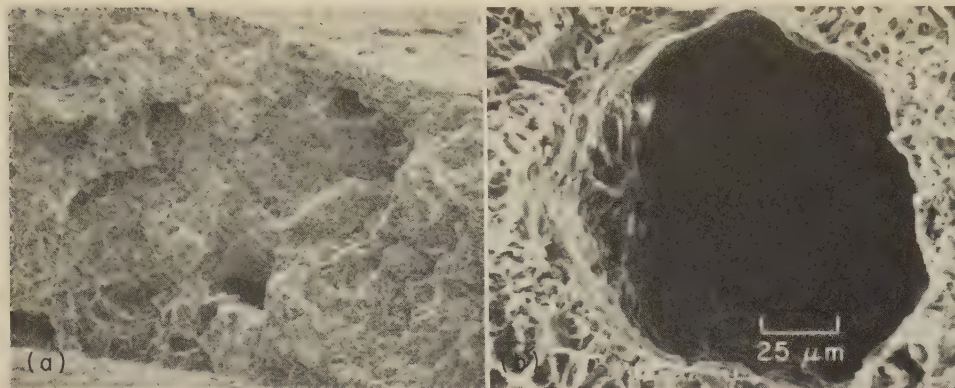
Fig. 22. Porosity in a fracture of a cast aluminum alloy A357 blade from a small air turbine. The blade fractured by overload from an impact to its outer edge.

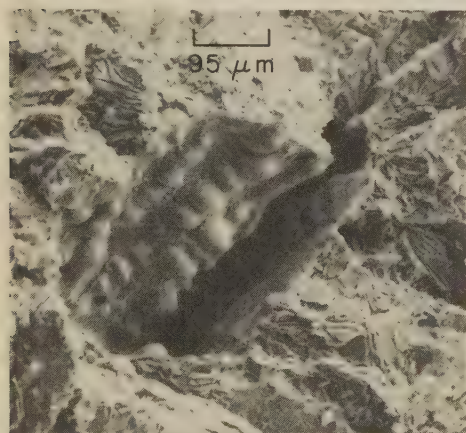
Fig. 23. Shrinkage void with dendrite nodules on a fracture surface of a cast aluminum alloy A357-T6 gear housing that broke by overload

Figure 23 shows a shrinkage void intersected by the fracture surface of a cast aluminum alloy A357-T6 gear housing. The dendrite nodules in the void indicate that the cavity was caused by unfavorable directional solidification during casting. The fracture was caused by overload.

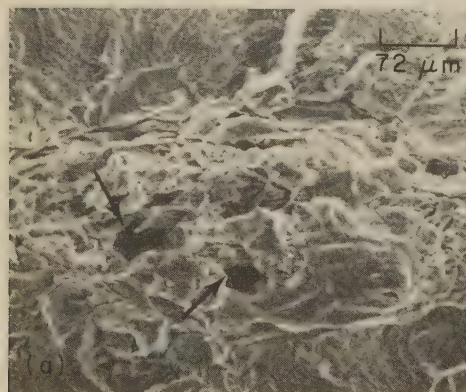
Fig. 24. Fatigue-fracture surface of a resistance spot weld that broke during bond testing of an aluminum alloy 7075-T6 specimen. (a) Note voids (at arrows) caused by molten-metal shrinkage in the weld nugget. (b) Both fatigue striations and shrinkage voids are evident, which indicates that the fracture path favored the porous areas.

Figure 24 shows SEM fractographs of the surface of a fatigue fracture in a resistance spot weld that broke during bond testing of an aluminum alloy 7075-T6

specimen. The voids in the weld nugget are apparent in both fractographs. The fatigue-fracture path appears to favor the voids.

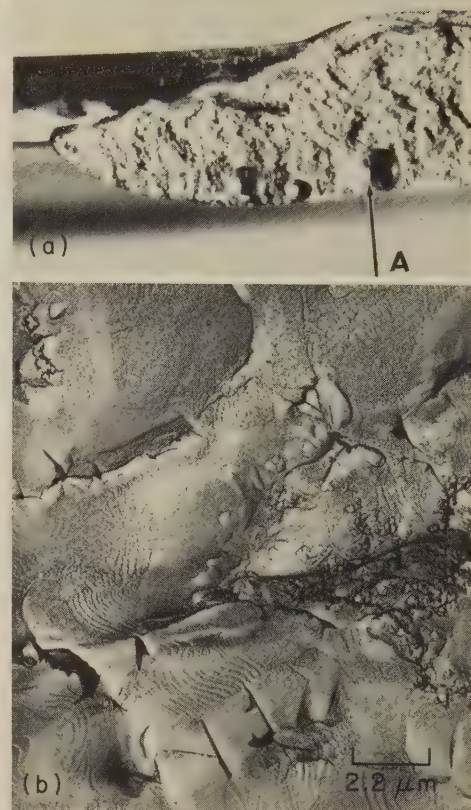
(a) A light fractograph, at 3×, showing a trapped-gas cavity at A. (b) A TEM fractograph, at 4550×, showing trapped-gas cavities that have smooth interior surfaces containing elaborate steplike geometric patterns.

Fig. 25. Two views of a fracture surface of aluminum alloy 2014 weld metal showing trapped-gas cavities

The fracture shown in Fig. 25 revealed cavities that had formed from gas trapped during solidification of aluminum alloy 2014 weld metal. These spherical cavities had smooth surfaces with steplike geometric patterns (see Fig. 25b). Figure 26 shows similar features on the surface of a void in a gas tungsten-arc weld in maraging steel; the weld was made using modified 18Ni-9Co-5Mo steel filler wire.

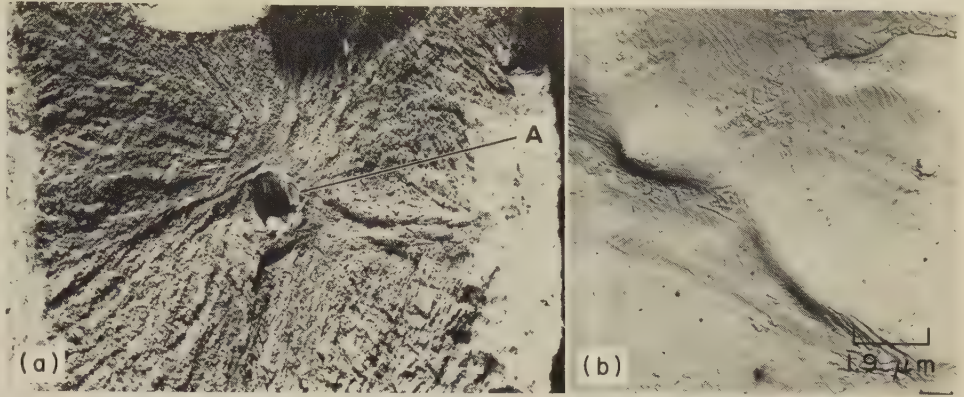
Fig. 26. Fracture through porosity that was formed in a weld nugget during welding of 18Ni-7Co-5Mo maraging steel with modified 18Ni-9Co-5Mo steel filler wire. The surface of the void, A in (a), was fairly smooth and shiny to the edge but showed geometric patterns at high magnification (b).

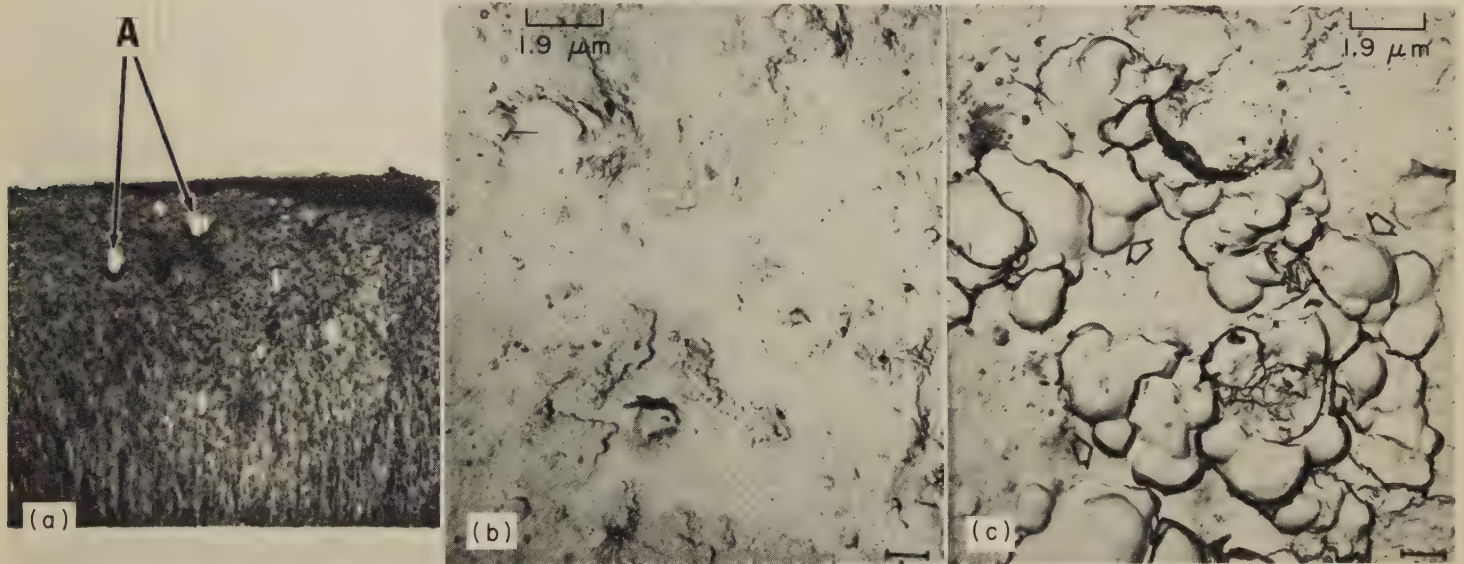
Fig. 27. Fracture through porosity in an aluminum alloy 2014 forging. At low magnification (a), the porosity appears as small, shiny, flake-like regions (arrows at A), but at high magnification some areas show typical geometric patterns (b) and oxide scale (arrows in c).

Traces of porosity are sometimes found in forgings. Figure 27 shows a fracture in an aluminum alloy 2014 forging that contained porosity, which appears as small, shiny, flakelike regions. At high magnification, some areas of porosity show the same steplike geometric patterns as those shown in Fig. 25(b), and other areas show oxide scale. The presence of oxide scale probably accounts for the pores not "healing" during forging.

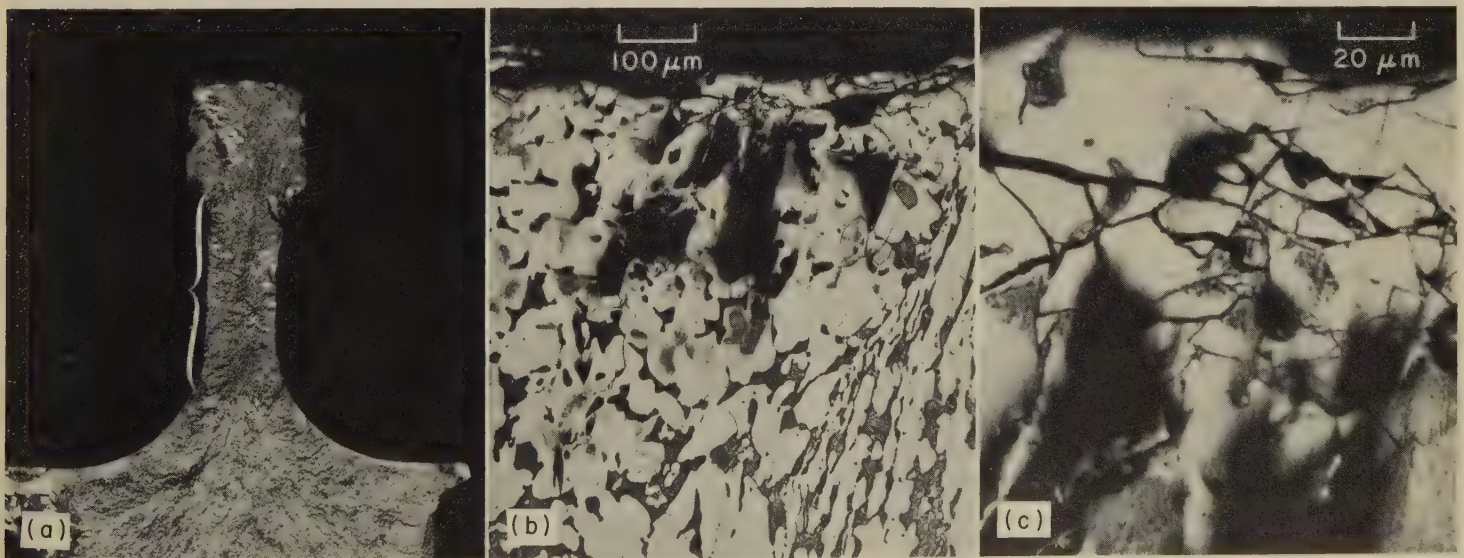
(a) Fracture in segregated area (bracketed) shows some evidence of porosity and appears much more brittle and granular than the remainder of the frac-

ture. (b) Metallographic section through the region of segregation and porosity. (c) Higher-magnification view of part of (b), showing extensive microcracking.

Fig. 28. Fracture through a region of segregation in an annealed titanium alloy Ti-6Al-4V (AMS 4928) forging

confirmed by comparing the microstructure and chemical composition of the material in the suspect region with those in other locations in the same part. A fracture through a region of segregation in an annealed titanium alloy Ti-6Al-4V forging is shown in Fig. 28(a). The appearance of the microstructure adjacent to the fracture is shown in Fig. 28(b) and (c).

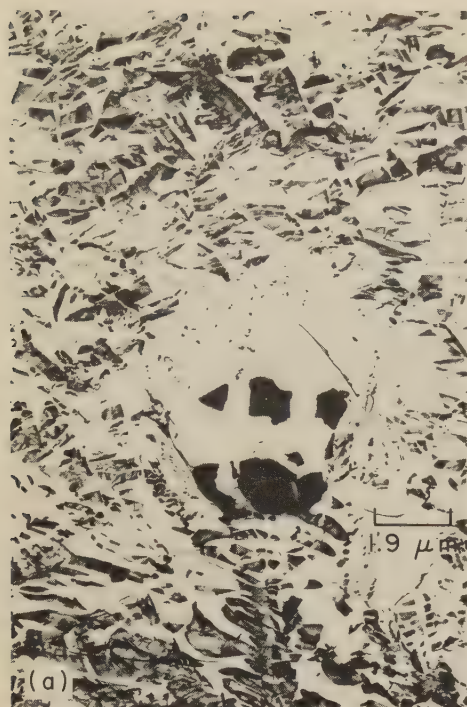
Fig. 29. Fracture surfaces of two fracture-toughness specimens of 18% Ni maraging steel containing different amounts of carbon and nitrogen, and showing different amounts of embrittling phase

Grain-boundary discontinuities are material discontinuities such as embrittling phases and melted eutectic. For example, the 18% Ni maraging steels become severely embrittled if they are heated to temperatures of 1093 C (2000 F) or higher and cooled slowly through the range of 982 to 760 C (1800 to 1400 F) without sufficient simultaneous hot working. The embrittlement is of an intergranular nature, and fracture takes place predominantly along prior austenite grain boundaries. Fracture surfaces of fracture-toughness specimens of unembrittled, heat treated maraging steels consist almost entirely of equiaxed dimples, but fracture surfaces of specimens of embrittled maraging steel are intergranular, with quite smooth and only slightly curved contours. Figure 29(a) is a TEM fractograph of an extraction replica showing the segregate embrittling phase in a com-

mercial maraging steel that contained 0.027% C and 0.001% N. The segregate phase has been identified as titanium carbonitride, $Ti(C,N)$. It appears to be an almost continuous film. In Fig. 29(b), an embrittled experimental heat of maraging steel with a higher nitrogen content but lower carbon (0.004% C, 0.003% N) shows evidence of a smaller amount of the same embrittling phase.

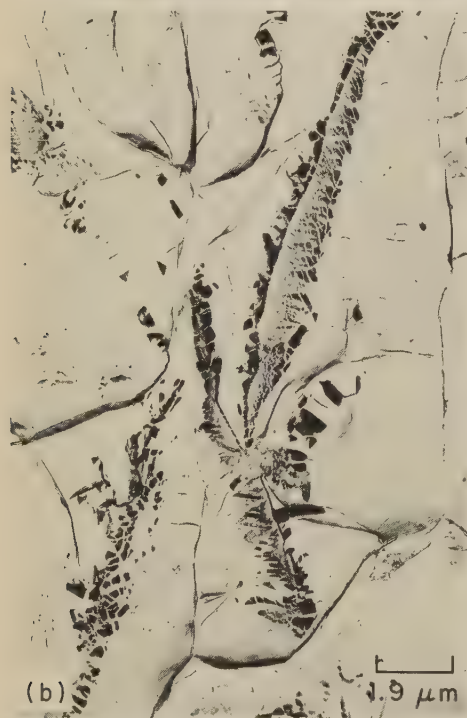
TEM fractograph (extraction replica) 5250×

(a) Maraging steel containing 0.027% C and 0.001% N. Slow cooling through the range of 982 to 760 C (1800 to 1400 F), without adequate accompanying hot work, precipitated a brittle film of titanium carbonitride at the grain boundaries. The dark particles present throughout this surface are fragments of titanium carbonitride that adhered to the replica.

(b) Maraging steel containing 0.004% C and 0.003% N. Like the steel shown in fractograph (a), this steel was also slowly cooled through the range of 982 to 760 C (1800 to 1400 F) without adequate accompanying hot work. Titanium carbonitride precipitated at the grain boundaries, but because of the lower carbon content of this steel compared with that of the steel in (a), a smaller amount precipitated.

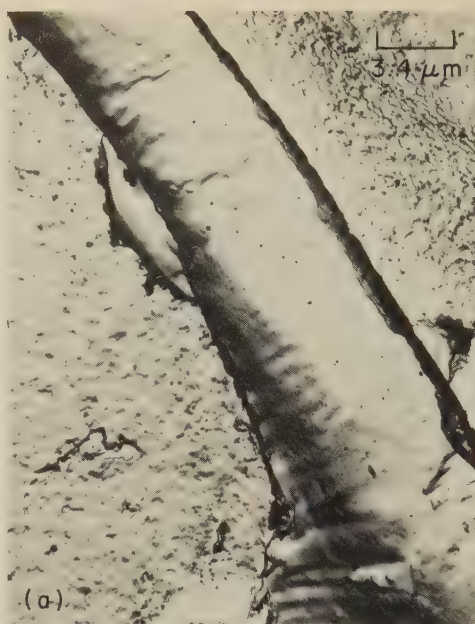
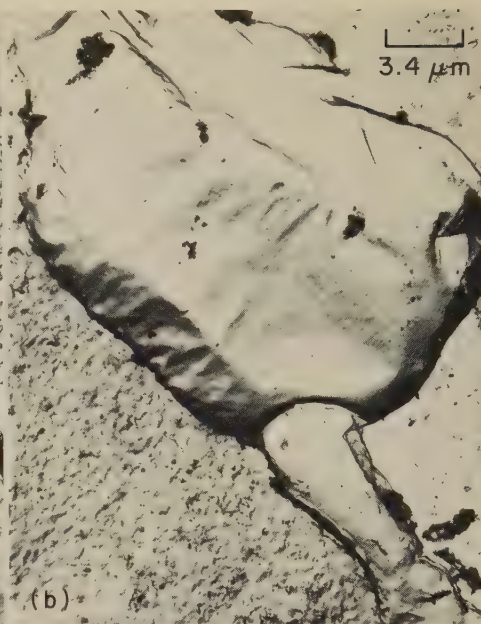
TEM fractographs

Fig. 30. Surfaces of a fracture in aluminum alloy 2014-T6 that resulted from overload at a high temperature caused by a fire. The smooth, rounded features resulted from eutectic melting of the alloy at the grain boundaries. The fracture surface of the matrix is featureless, except for the presence of an oxide film.

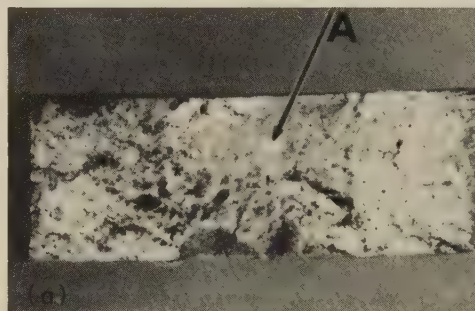
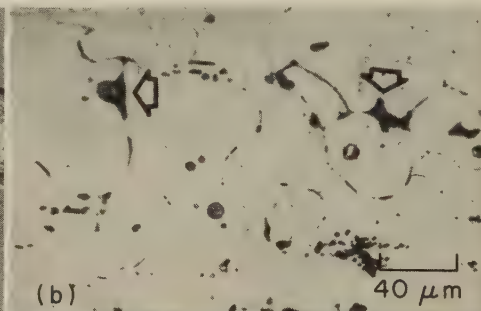
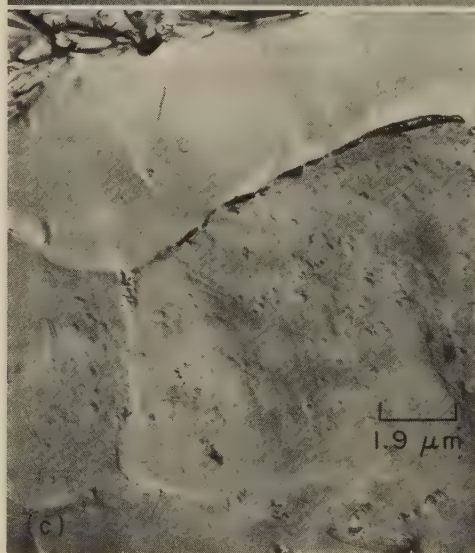
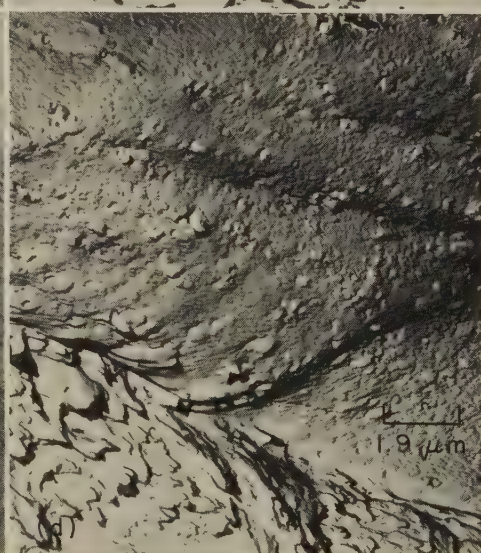
(a) Light-microscope fractograph, at 4×, showing the surface of the tension-overload fracture.

(b) Micrograph, at 250×, of an as-polished section taken near the fracture surface, showing evidence of intergranular eutectic melting (see arrows).

tograph (a). The facets in fractograph (c) are believed to have resulted from separation at melted grain-boundary eutectic. Note the region of small dimples at top left. The features at lower left in (d) are artifacts that resulted from tearing of the first-stage replica. The separated-grain facets in fractograph (c) are smoother than those in (d).

Fig. 31. Tension-overload fracture of a specimen of extruded aluminum alloy 2014 after it had been deliberately overheated to cause intergranular eutectic melting. Solution heat treatment of the specimen was at 527 C (980 F) for 30 min, and was followed by water quenching and aging at 171 C (340 F) for 8 hr.

of a specimen of extruded aluminum alloy 2014 produced the fracture surface shown in Fig. 31. The specimen had been overheated intentionally to produce eutectic melting. This fracture displays a few intergranular areas (which probably separated at melted grain-boundary eutectic) and small dimples.

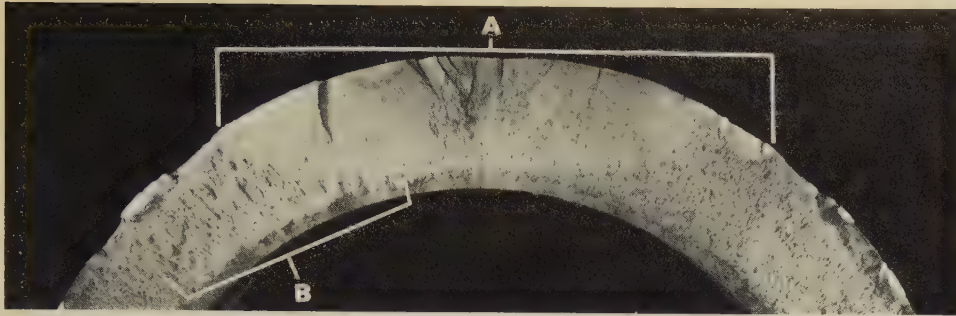
Light fractograph

Several fatigue-crack origins were found in the area indicated by bracket A. Numerous small discontinuous marks nearly perpendicular to the direction of crack propagation were determined by

Fig. 32. Fatigue fracture through a region of unfavorable grain flow and large inclusions in an aircraft landing-gear axle forged from 4340 steel

Grain flow in an unfavorable direction may be indicated by a woody fracture in some materials and by a flat, delaminated appearance in others. A region of woody fracture is marked by bracket B in Fig. 32, which shows a fatigue fracture in a forged

4340 steel aircraft landing-gear axle. The fatigue fracture occurred in a region where the resistance of the material to fatigue cracking was low because the fluctuating loads were applied nearly perpendicular to the direction of grain flow. In high-strength aluminum alloy extrusions and hot rolled products, tension loads are occasionally applied perpendicular to the flow direction, which may cause splitting along flow lines. This somewhat resembles the pulling apart of laminated material. Splitting may also appear as secondary cracks perpendicular to the primary fracture when these materials are broken by bending loads.

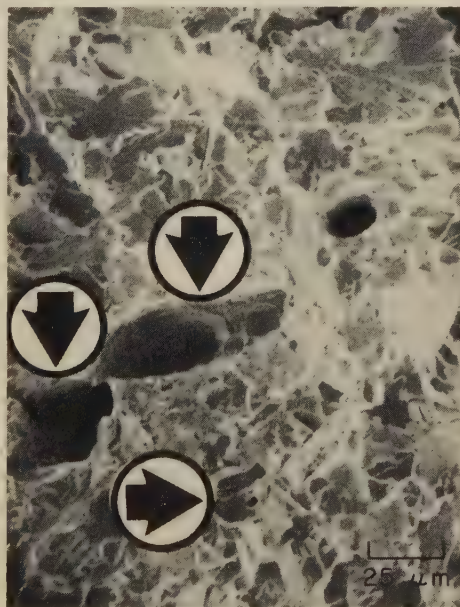
SEM fractograph

Fig. 1. Microvoids (at arrows) in a cleavage fracture in ASTM A302, grade B, pressure-vessel steel (Ref 2)

A method of appraisal sometimes used is to expose a partial fracture by cleavage of the remaining unfractured section at subzero temperature, thus avoiding cutting and any flow it might cause at the crack surface of interest. It will also avoid confusion as to which fracture area was initial and which final. For example, Fig. 1 and 2 (from Ref 2) show cleavage-fracture surfaces in an alloy steel specimen that had been precracked in fatigue, strained in tension almost to total fracture at room temperature, chilled to liquid-nitrogen temperature, and fractured by cleavage—first perpendicular to the previous tension, and then again at a right angle. Figure 1 shows the first

Studies of the amount of plastic deformation existing in fracture surfaces have been made with selected-area electron-channeling-pattern techniques. (The patterns are made possible by the fact that backscattered electrons emitted by a fracture surface in a scanning electron microscope will provide a spatial pattern that is blurred if the surface layers have been deformed but that is sharp if the surface is undeformed.) Using this technique, Stickler and Booker (Ref 3) have examined cross sections of cracks, and Newbury, Christ and Joy (Ref 4) have studied deformation on fracture surfaces. This technique and examination of thin-foil specimens are helpful in revealing the microscopic deformation associated with crack growth. Such a technique might also be useful in assessing the degree of deformation around microvoids, such as those shown in Fig. 1 and 2.

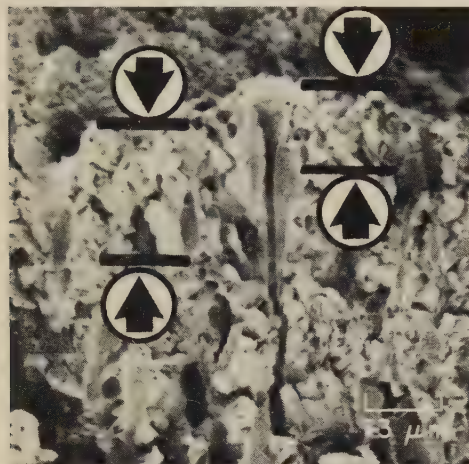
SEM fractograph 137X

The tensile direction during microvoid growth was vertical. The surface of the first cleavage fracture is visible at the top of the view. The horizontal bars between the sets of vertical arrows give an indication of the depth of the microvoids.

Fig. 2. Microvoids in the same specimen (with the same treatment) as shown in Fig. 1, but with the cleavage fracture normal to that in Fig. 1 (Ref 2)

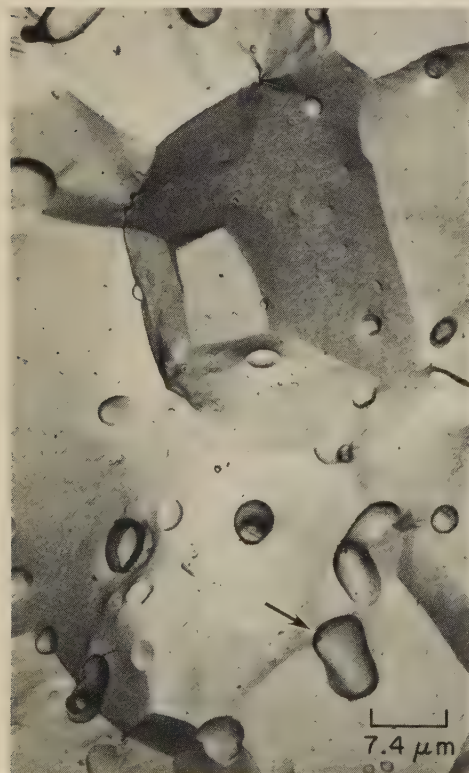
TEM fractograph (p-c replica) 1350X

Fig. 3. Pore sizes and shapes revealed by fracturing a specimen of sintered tungsten. The arrow points to a pore.

Figure 3 shows another structure revealed by fracture sectioning: the pores in sintered metals. Exposure of structures by fracturing is a preferred technique for such materials as gems, wood,

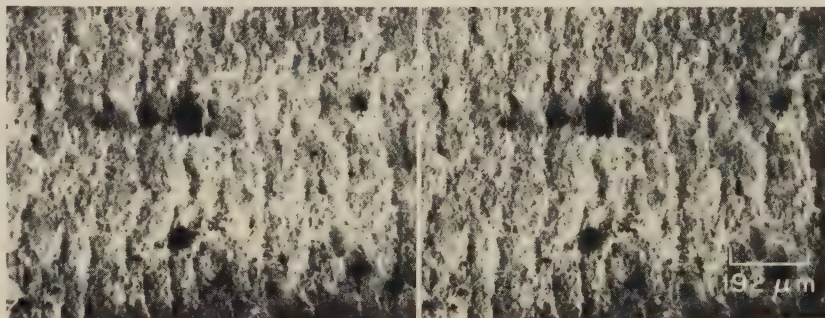
SEM fractograph (stereo pair)

Fig. 4. Alternating ridges and valleys, appearing as vertical lines, formed in the fibrous fracture surface of a 10% Ni, 2% Cr, 1% Mo, 8% Co steel. Fracture propagated from left to right.

vealed by Light Microscopy. Fracture surfaces with these fibrous ridges are shown in Fig. 2 and 3(b) in that article (see pages 27 and 28) and in Fig. 4 here. The spacing of the fibrous ridges has been related to fracture toughness (Ref 5), and the mechanisms of their formation have been discussed (Ref 6).

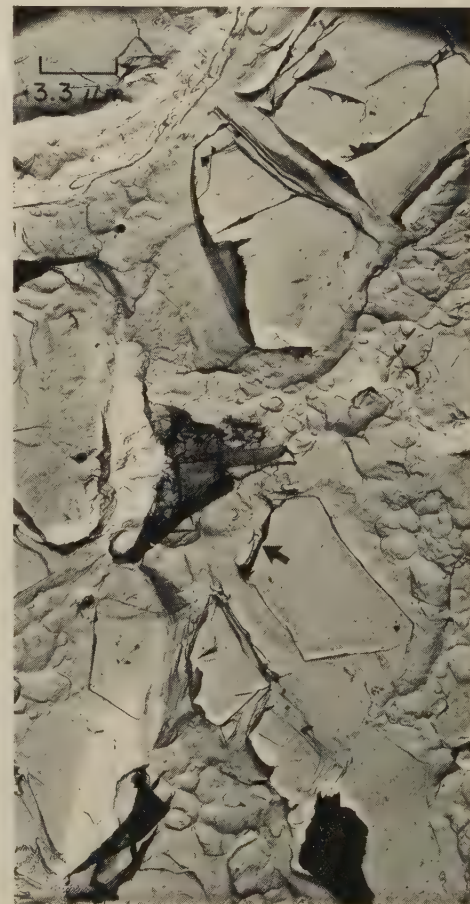
TEM fractograph (p-c replica) 3000X

Fig. 5. A low-energy fracture along the rolling plane in 18% Ni maraging steel. Fracture started at inclusions, such as at arrow, which had broken during rolling.

It is often possible at higher magnifications to see the microconstituents that represent the weak component that may be responsible for fracture. This has been done for the effects of sulfide-inclusion spacings on fracture toughness (Ref 7, 8). Fracture originating at broken inclusions in a maraging steel is shown in Fig. 5.

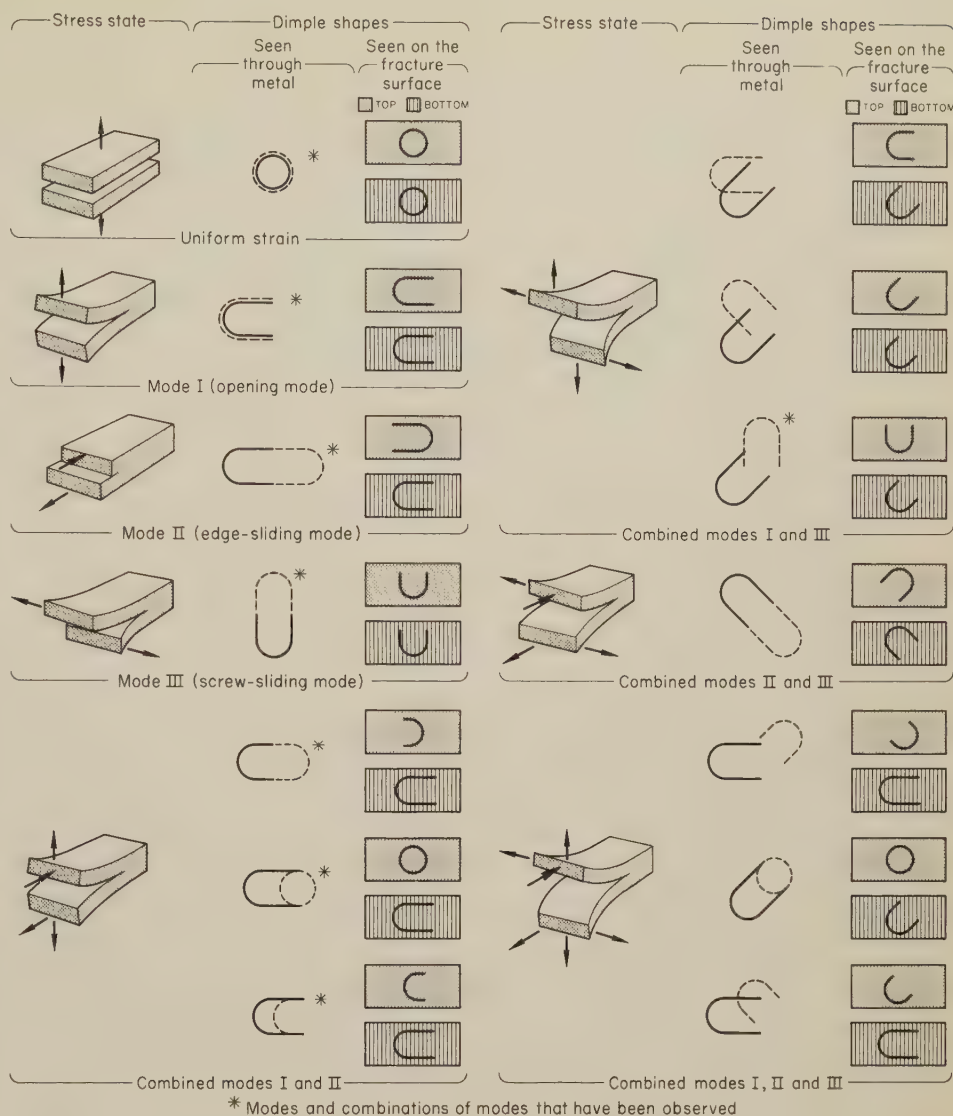
Fig. 6. Fourteen probable combinations of mating dimple shapes resulting from different stress states, which cause the crack tip to deform by various modes

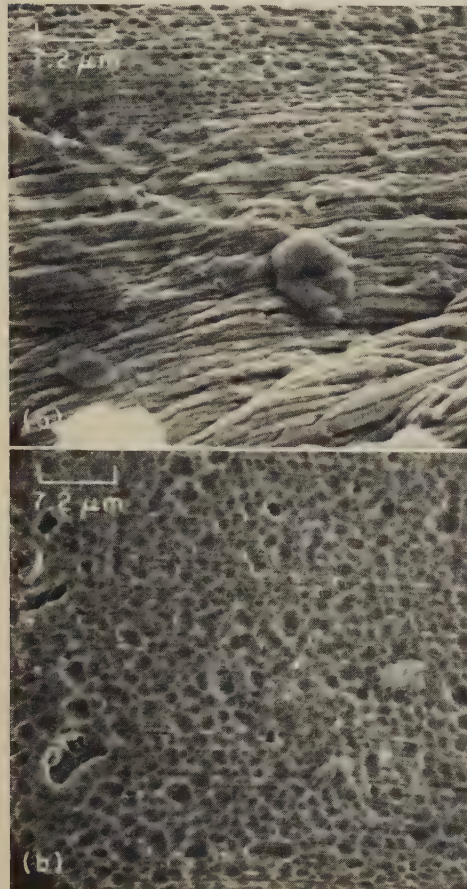
SEM fractographs Both at 1400×

(a) Artifact that was produced by hacksaw cutting a thin specimen from the cracked area is shown in the lower part of the fractograph.

(b) Surface features of the crack consist of corrosion-produced round-bottom pits.

Fig. 1. Artifact produced in preparing a specimen for examination by scanning electron microscopy. Specimen was cut from a cracked area of a cast CN-7M stainless steel pump impeller used for pumping sulfuric acid. (Example 1)

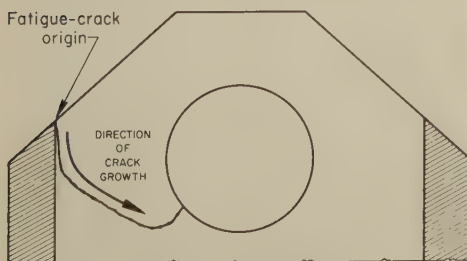
Fig. 2. Schematic diagram showing the location of the crack origin and the direction of the crack growth in the fatigue fracture of the 4340 steel rotor fitting of Fig. 3 (Example 2)

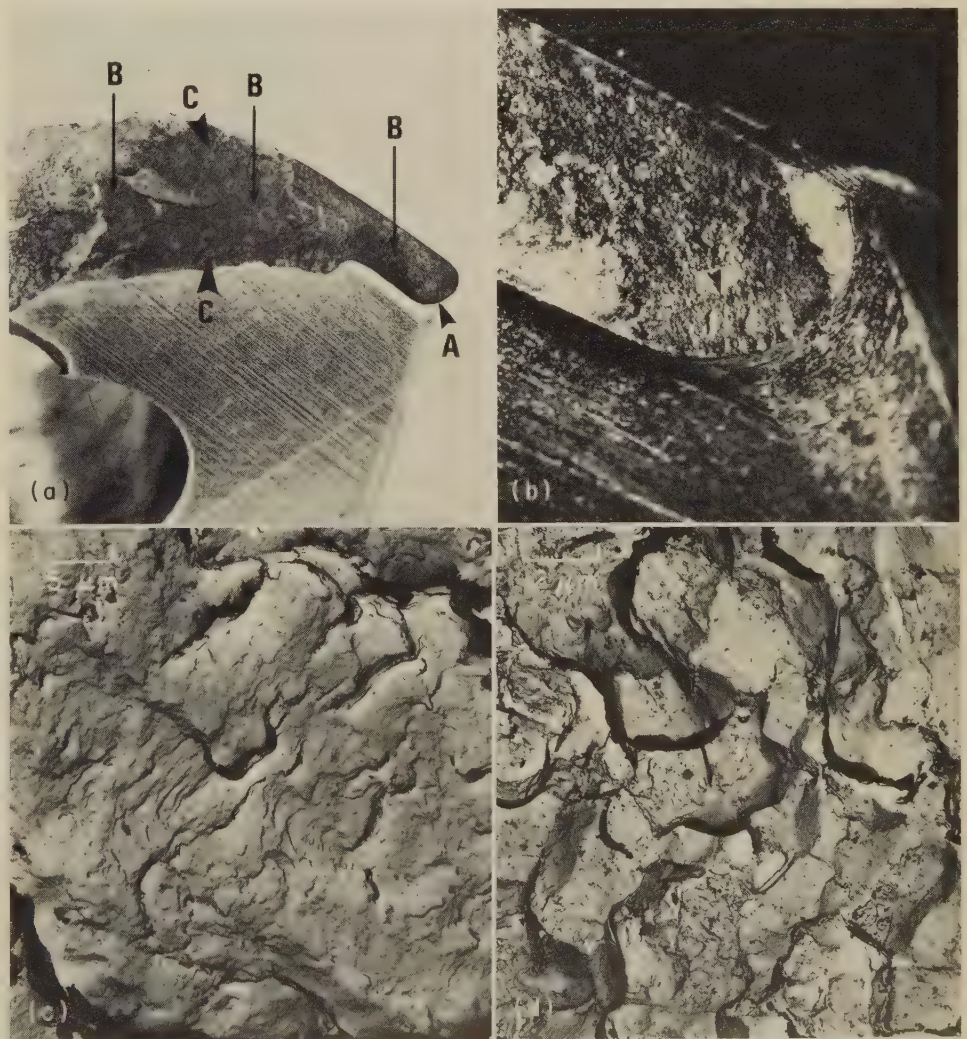
(a) Light fractograph, at 1.6×, showing fatigue-fracture zone A, intergranular-fracture zones B and shear-lip zones C of the fracture. (b) Light fractograph, at 10×, showing area A at a higher magnification and the fatigue-fracture origin. (c) TEM fractograph (plastic-carbon replica), at 6800×, showing poorly defined fatigue striations in area A. (d) TEM fractograph (plastic-carbon replica), at 800×, showing intergranular fracture at area B.

Fig. 3. Fracture surface of a 4340 steel rotor fitting; see also Fig. 2 (Example 2)

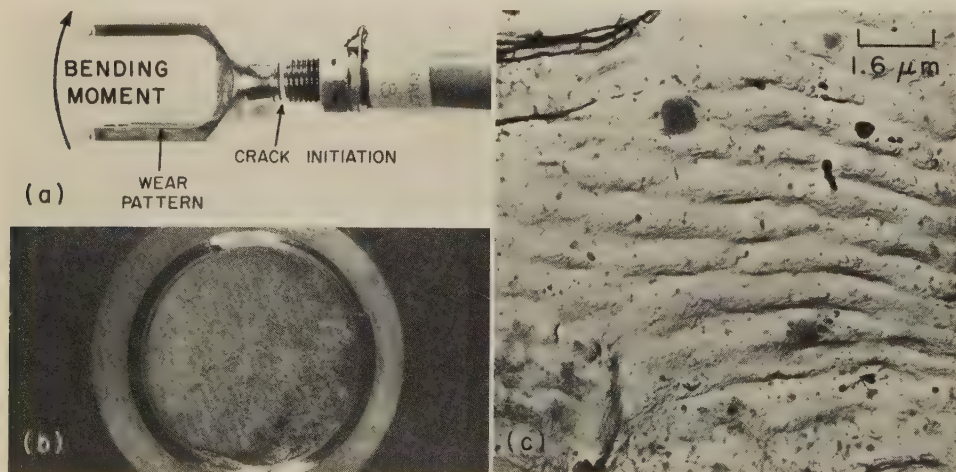
(a) Photograph, at 0.4x, of fractured clevis, showing orientation of bending moment, wear-pattern location, and crack-initiation site in shank. (b) Light fractograph, at 2.8x, showing fracture surface of clevis. (c) TEM fractograph (p-c replica), at 6400x, showing fatigue striations on fracture surface.

Fig. 5. Fracture of a titanium alloy Ti-6Al-4V clevis from a control system for a rotary-wing aircraft (Example 5)

Evidence of a wear pattern in the form of an arc on the inner surface of one of the fingers of the clevis (Fig. 5a) suggested that the shank had been subjected to bending-moment forces oriented favorably for crack initiation at the observed origin. Investigation indicated that the wear pattern and the cyclic bending loads had resulted from malfunction of a bearing in the linkage component attached to the clevis. This malfunction was attributed to faulty assembly procedures during installation of the bearing.

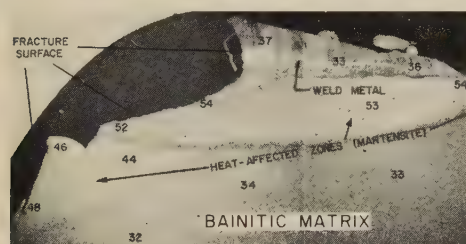
Macrograph (etchant: 2% nital) 12X
Fig. 7. Metallographic section of the 4340 steel axle of Fig. 6 in the region of crack origin, showing the weld metal, the heat-affected zone adjacent to the weld metal, and the Rockwell C hardness at various locations (Example 5)

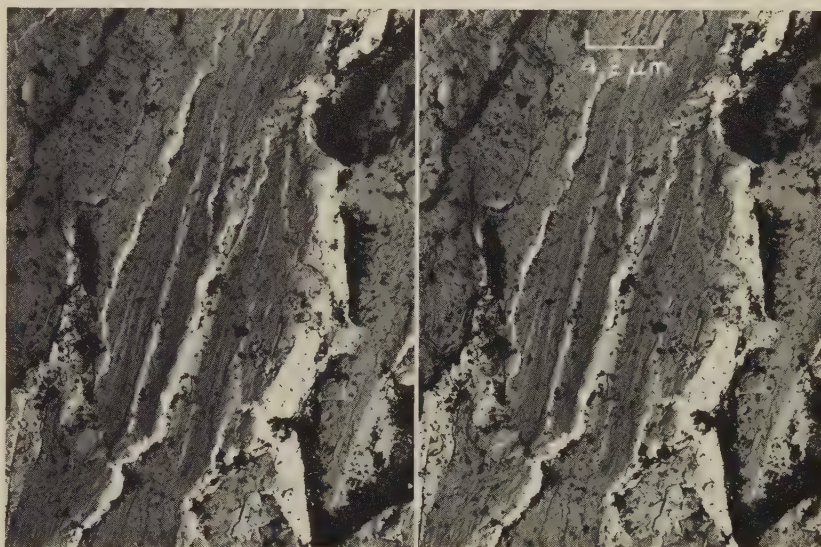
TEM stereo pair (p-c replica)

2400×

When viewed in 3-D, this stereo pair shows a massive ridge running from top to bottom at the left, with pronounced cleavage steps on its right-hand slope. The corrosion debris remaining from service and extracted by the replica may be seen projecting from the surface.

Fig. 10. Transgranular cleavage in an area of the surface of the hydrogen-embrittlement fracture of the type 431 stainless steel mushroom-head closure shown in Fig. 9. See also Fig. 11. (Example 7)

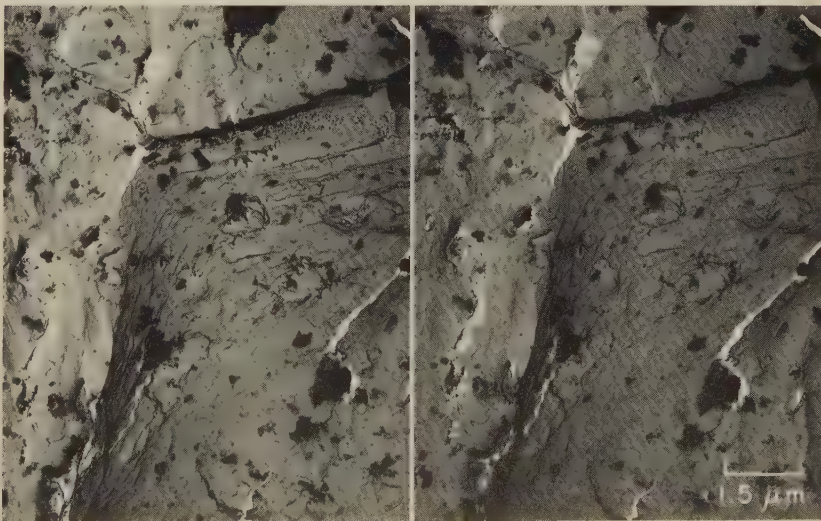
TEM stereo pair (p-c replica)

6600×

When viewed in 3-D, the somewhat rounded separated-grain surfaces show cavities akin to dimples in appearance but more probably sites of previous intergranular inclusions. The corrosion debris may be seen projecting from the fracture surface.

Fig. 11. Intergranular separation in an area of the surface of the hydrogen-embrittlement fracture of the type 431 stainless steel mushroom-head closure of Fig. 9 and 10 (Example 7)

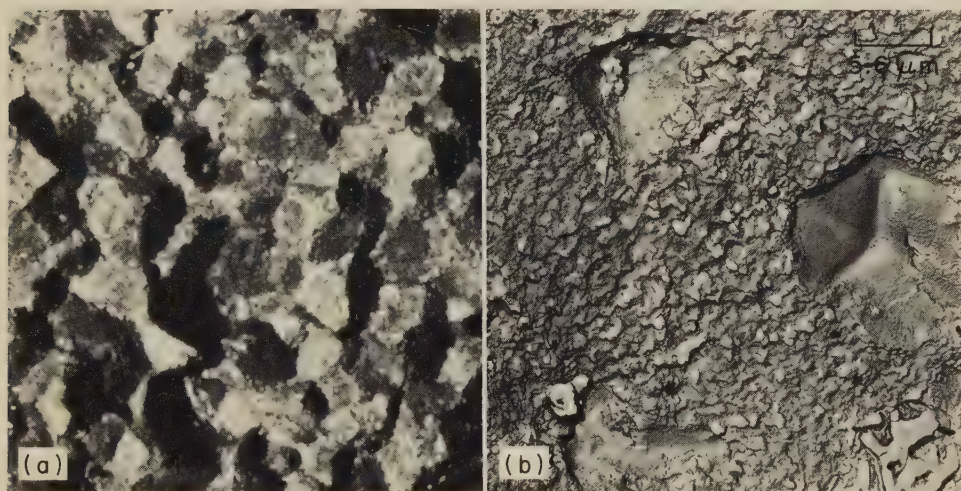
Light fractograph 22× TEM fractograph (p-c replica) 1800×
(a) Coarse separated-grain facets indicate that hot pressing produced a new macrostructure unrelated to original powder-particle size. (b) Fractograph at higher magnification shows oxidation and inclusions on a separated-grain facet.

Fig. 12. Intergranular fracture of a powder metallurgy compact made of nickel-base heat-resisting alloy 713LC and creep-to-rupture tested in air at 760 C (1400 F) and 585 MPa (85 ksi)

Whether or not a fracture is intergranular can often be determined by inspection at low magnification. (Higher magnifications are sometimes necessary for positive identification, particularly for fine-grained materials.) Fractography at assorted magnifications can usually yield clues of the underlying cause of grain-boundary separation. For parts prepared from hot isostatically pressed powder metallurgy compacts, for example, examination of creep-to-rupture surfaces can provide information on how thoroughly the particles of the powder were bonded together. Figure 12 shows a fracture surface of a powder metallurgy compact of nickel-base heat-resisting alloy 713LC that was creep tested to rupture at a temperature of 760 C (1400 F) and a stress of 585 MPa (85 ksi). The coarse separated-grain facets are clearly evident in Fig. 12(a), indicating that the hot pressing produced a new macrostructure unrelated to the original powder-particle sizes and orientations. A higher-magnification view of one of the separated-grain facets (Fig.

12b) shows that inclusions were located at grain boundaries. Other surface features are oxidation products, which formed before cooling from the test temperature. For more complete appraisal of factors contributing to fracture, metallographic examination of sections normal to the fracture surface would be essential to confirm more precisely the microstructure of the powder metallurgy compact and the grain-boundary constituents.

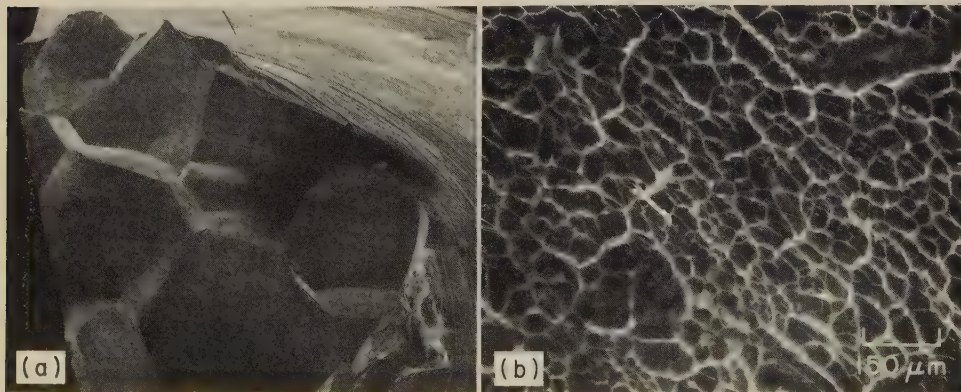
SEM fractographs 10× (a); 67× (b)

Fig. 13. (a) Tensile-test fracture surface of a specimen of alloy Al-4.2Cu, showing separated-grain facets. (b) Uniform dimples on a portion of one facet of the fracture surface shown in (a). This is characteristic of microvoid coalescence in the grain-boundary zone.

The microstructure of the specimen indicated alloy depletion at grain boundaries.

Fractographic examination provides information concerning local properties of an alloy at its grain boundaries. Where the yield strength of grain-boundary zones is lower than that of the matrix, fracture can develop by microvoid growth and coalescence within the grain-boundary zones. The fracture surfaces resulting from this process are characterized by numerous small dimples superimposed on separated-grain facets, as shown in Fig. 13(b). Figure 13 presents views, at two magnifications, of a tensile-test fracture in a coarse-grained, high-purity aluminum-copper alloy. Examination of this fracture surface at a magnification where the field of view is of the order of a single grain can lead to misinterpreta-

tion of the uniform dimples as evidence of transgranular fracture instead of intergranular fracture. Careful examination of a fracture surface over a wide range of magnifications is imperative for accurate interpretation of fine-scale topography.
